January 2025

Franklin Street Sites - Facility Assessment

Hancock MI, 49930

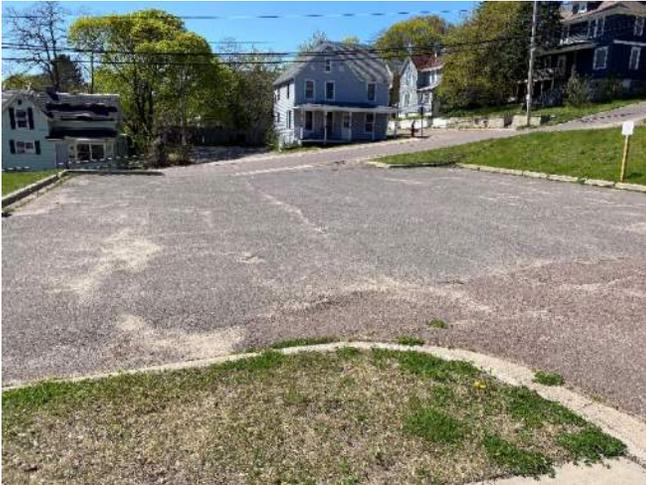
NW Parking Lot

The two parking lots are graded to sheet flow stormwater onto Scott Street. There are two storm leads that connect to this site. One storm lead runs along the north side of the building. This lead serves storm catch basins (#100005 and #100006) and has leads that run into the north side of the building. There is an in-line cast iron trap (impassable with camera), located in-between the on-site catch basin (#100006) and the City of Hancock main connection on Scott Street. The age of the service lead is approximately 60 years, and the condition is unknown.

It is recommended to remove the in-line trap on the north storm sewer service and further investigate the line to the point it ties in at Scott Street. On the south side of the building, bulkhead and partial replacement of the storm line in-between structures #100003 and #100004 will be necessary to route footing drains into structure #100003. It is also recommended to replace and reroute the deteriorating sanitary sewer lines to ensure proper pipe grade and potential cross contamination within the storm structures. Removing the in-line trap near structure #100004 and utilizing the structure for sanitary sewer would allow better access. Excavation, bulkheading, and new pipe installation will be required.

Reconstruct the asphalt parking lots to gather stormwater runoff and perform select repairs on damaged curb-and-gutter and sidewalk.

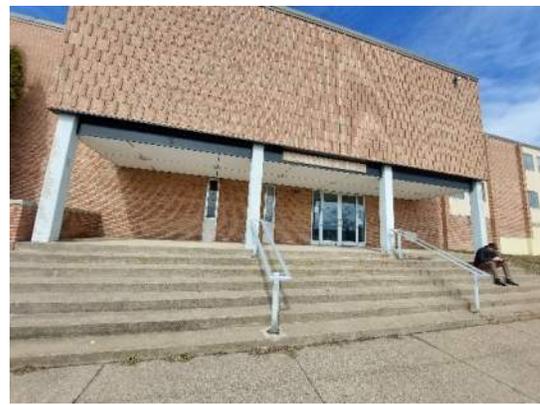
The majority of the building is faced with brick masonry and EIFS/Stucco. There are some small areas of brick which show efflorescence and some small areas in need of re-pointing. The kitchen addition is the area that has the most concern regarding the condition of the brick. It is apparent that there has been water issues and attention is needed at the scupper locations where there has been a severe degradation of the mortar joints. There is some cracking visible and some joint deterioration in the EIFS/Stucco. The EIFS/Stucco was not the original cladding of the building and the exact construction of the wall system in these areas is unknown.

Insulation in the wall system is unknown but does not appear to be adequate per current standards and code requirements.

Overall, the exterior wall system requires some maintenance but is functional and has over 10 years of life.

Perform maintenance at building exterior, replacing existing sealants. Re-point damaged areas of brick especially at kitchen addition. Install conductors at the scuppers from the kitchen addition roof to avoid further damage to the brick surface.

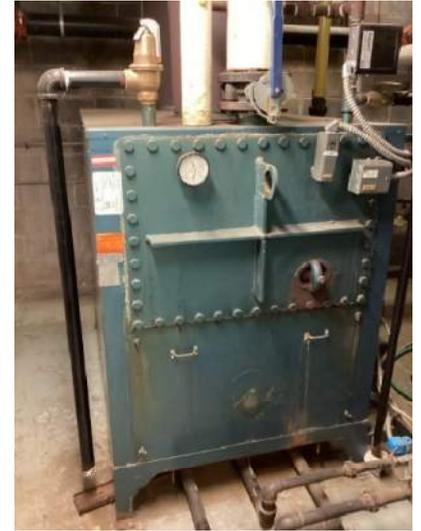
The building's heating system consists of a 2,000 MBH hot water Rite boiler that was installed in 1988. The unit is still in good operating condition but is approaching 40 years of service. The boiler also feeds the Nikander Hall addition hydronic mechanical equipment. The pumps located in the mechanical room are still in good condition. The heating distribution piping is a combination of schedule 40 black pipe and copper pipe. The offices, classrooms, kitchen, and dining hall are heated with convectors and finned tube radiation and about half of them are currently working. The convectors and finned tube are controlled in zones, so each room does not have individual control. Two-unit ventilators provide ventilation air for the kitchen and dining hall but have been taken out and ductwork has been disconnected. All ductwork and diffusers in the kitchen and dining hall have been left in place. A unit ventilator, that is not operational, on the ground floor provided ventilation air to multiple rooms. There is currently no ventilation air being provided to the building. The restrooms have exhaust ductwork connected to powered roof/ceiling exhaust fans that were not operating while onsite.

The compressor for the pneumatic control system looks to be original to the building. The air lines are in place and operational. The compressor has been running continuously during every visit. It seems there may be a leak in the system.

Replace the boiler and pumps. Replace the nonfunctioning convectors and finned tube radiation. Add ventilation to the spaces in the building as required per code. Replace exhaust fans or add energy recovery units for the restrooms. Remove pneumatic control system and replace with a digital control system.

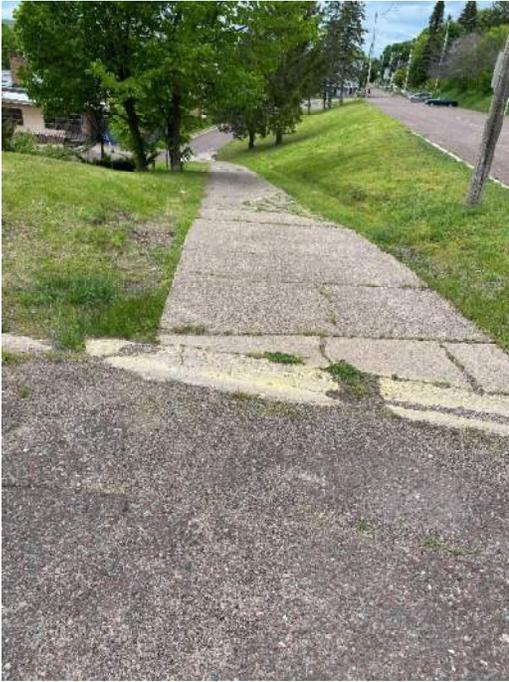
Sidewalk: N Parking lot to Service Drive

The building storm sewer joins into the Mannerheim Hall system at structure #100002, through structure #100001. Structure #100001 collects storm and sanitary sewer. Video from a vertical pipe cleanout in the garage area weaved under the slab, collecting what seemed to be roof drains, along with wash sink waste, and dumped into structure #100001.

It is recommended to separate the sanitary connections from the roof drains that connect into structure #100001. Structure #100001 should be a storm sewer only structure.

Provide ADA entrances to levels of the building that will be intended to serve as a public entrance. The most feasible entrances for ADA access from a parking spot to the building would be from the north parking lot to the northeast entrance and on-street Franklin parking to the southwest basement entrance. Perform miscellaneous curb-and-gutter and sidewalk repairs.

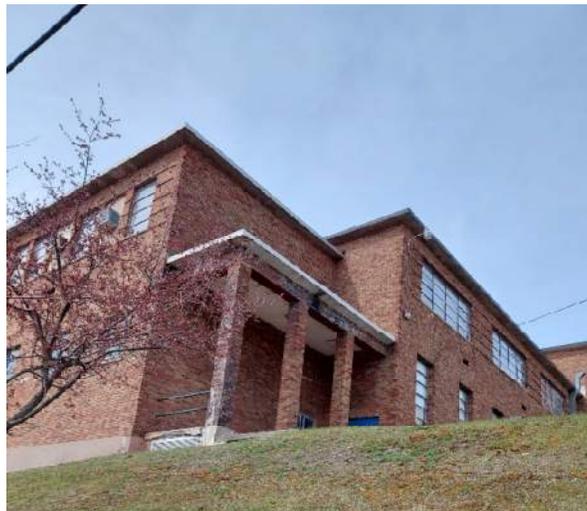
The majority of the building is faced with brick masonry. There are some small areas of brick which show efflorescence, especially at the east portico, and some visible cracks in need of re-pointing. There is also damage evident at the terrace where a portion of wall was removed.

Perform maintenance at building exterior, replacing existing sealants. Re-point damaged areas of brick especially at east portico.

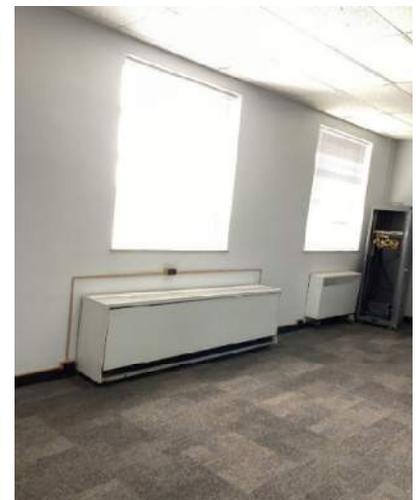
The majority of the first floor has an air handling unit (AHU) with duct heating coils that are fed from the hot water boilers in Mannerheim Hall. The pumps are located in the mechanical room in Nikander Hall and some of the hydronic piping requires patching or replacement. The AHU includes heating, cooling, and ventilation and the unit was not in operation during the walkthrough. The cabinet unit heaters and unit ventilators located throughout the building are served by a steam boiler located in the Wargelin Hall boiler room. There is some ductwork and grilles/diffusers on the second and third floor, but it is unknown where the unit is located or if it is operational. Some rooms have wall mounted A/C units. There are grilles in each of the toilet rooms ducted to exhaust fans.

The compressor for the pneumatic control system looks to be original to the building. The air lines are in place, but it is unknown if they are operational.

Verify the age of the AHU's and if they are operational. Verify they are sized appropriately for the spaces and there is adequate ventilation. Add new units and replace existing units as needed to meet ventilation requirements. Remove the steam piping throughout the building and cap the pipes where they come from Wargelin Hall. Remove and replace all convectors. Add boilers and pumps to the mechanical room in Nikander Hall and route new hydronic piping to heating coils and convectors.

Remove all pneumatic controls and air lines and replace with a digital control system.

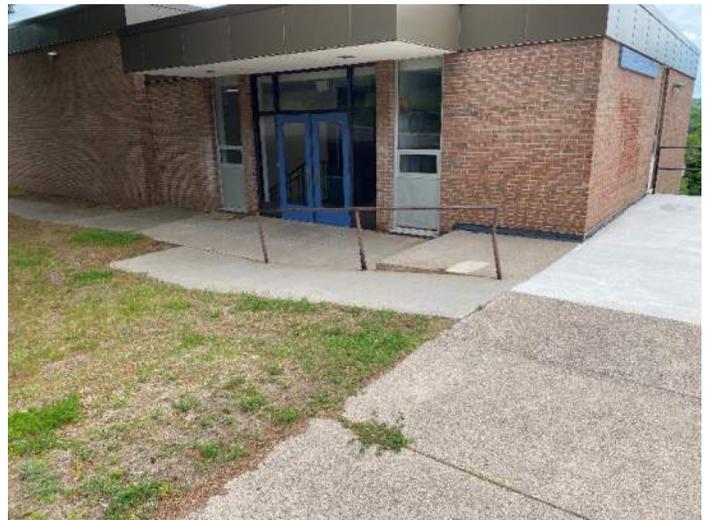
NW Entrance (Summit Street)

An approximate 21 car parking lot is located on the north side of the site, accessed from Summit Street. This lot provides access to both Wargelin and Nikander buildings. This lot is surrounded by a ~12-foot-wide sidewalk. The cross-slope of the sidewalk is greater than 2.0 percent and the ramp into the parking lot is greater than 8.33 percent, not meeting ADA guidelines. The surface of this parking lot is a mix of concrete and asphalt. This is the same parking lot addressed in the Nikander assessment. The asphalt surfaces in the parking lots are deteriorating and the grades show signs of settlement.

It is recommended to perform further testing and inspection of the sanitary lines to determine the condition of the systems along with connection points. This may include smoke test to confirm the roof drain connections to the sanitary, dye testing, and further video investigation. The site storm and sanitary sewers should be separated and tied into the city's respective system.

Repair the chain-link fence, miscellaneous curb-and-gutter, and sidewalk flags that have settled and broken.

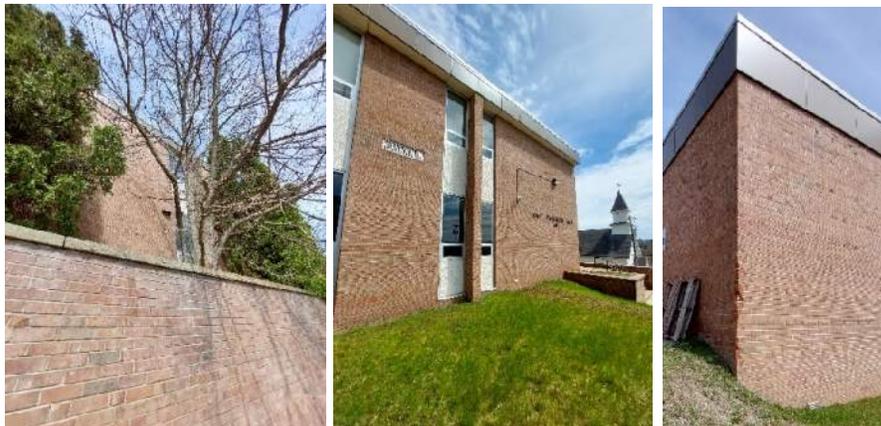
The majority of the building is faced with brick masonry in good condition. There are some small areas of brick which show efflorescence especially at the exterior retaining walls on the south side. The concrete caps on the retaining walls have open joints. There are a few small areas of damaged brick including at the southeast corner of the boiler room and on the west side at the terrace where a wall was removed. A few cracks are visible at the exterior. Additional cracks are visible at the interior of the

building in the exterior CMU walls. Areas of particular note are the exterior wall of the Physics/Chemistry room on the second floor, classrooms in the Northeast corner of the first floor and the Women’s bathroom on the third floor.

Re-point concrete caps at exterior retaining walls. Repair damaged masonry wall as required. Perform maintenance at building exterior, replacing existing sealants. Further investigation by a structural engineer should be performed to determine if there are underlying structural issues causing the cracking.

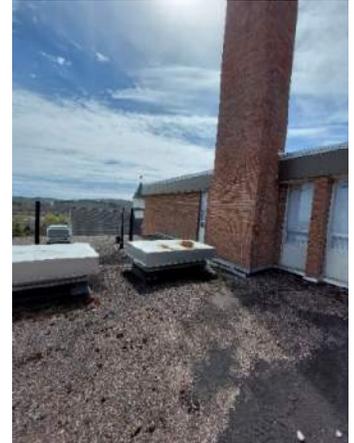
The majority of the roof surface is a loose laid EPDM membrane with rock ballast. The membrane shows some possible shrinking at the roof edges. Seams are not visible due to the ballast. Water marks inside the building indicate that there may be leaking in areas. Insulation of the roof system over the addition (1996) is 4” of rigid insulation which was standard for that time but may not meet current Code requirements. Insulation of the roof system over the original building was originally indicated to be 1” rigid insulation. It is unknown if additional insulation was added later, but it is expected that current insulation is less than current standards and code requirements. Roof drains are present and appear to be functional. Roof drain capacity was not verified.

A section of roof above the boiler room is an asphalt built-up roof. This area is in poor condition and leaking is evident at the interior.

Replacement of the entire roof system is recommended. A fully adhered membrane system is recommended (remove all existing ballast). Additional insulation could be added during roof replacement.

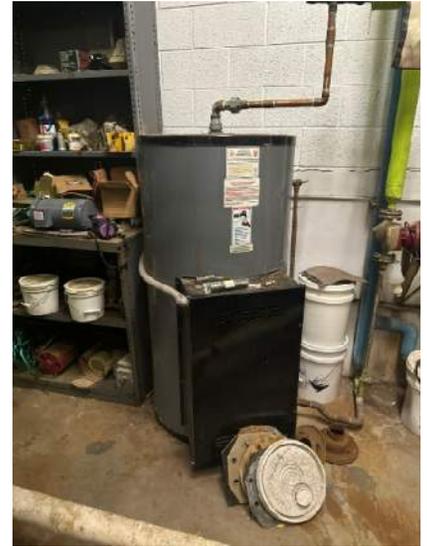
The domestic water comes into the building in the boiler room. After the meter, a pipe comes off the main and goes underground to Nikander Hall. There is an electric water heater in the boiler room that provides domestic hot water to the lavatories and sink throughout the building. The domestic water piping is copper, and the sanitary piping is cast iron. There are primary roof drains on the roof but no overflow drains. There is currently no fire suppression system in the building.

Replace all fixtures. Replace roof drains when roof is replaced and add overflow drains. Review the condition of the domestic water and sanitary piping. Replace the electric water heater with a gas water heater. Add fire suppression piping and sprinkler heads to the building.

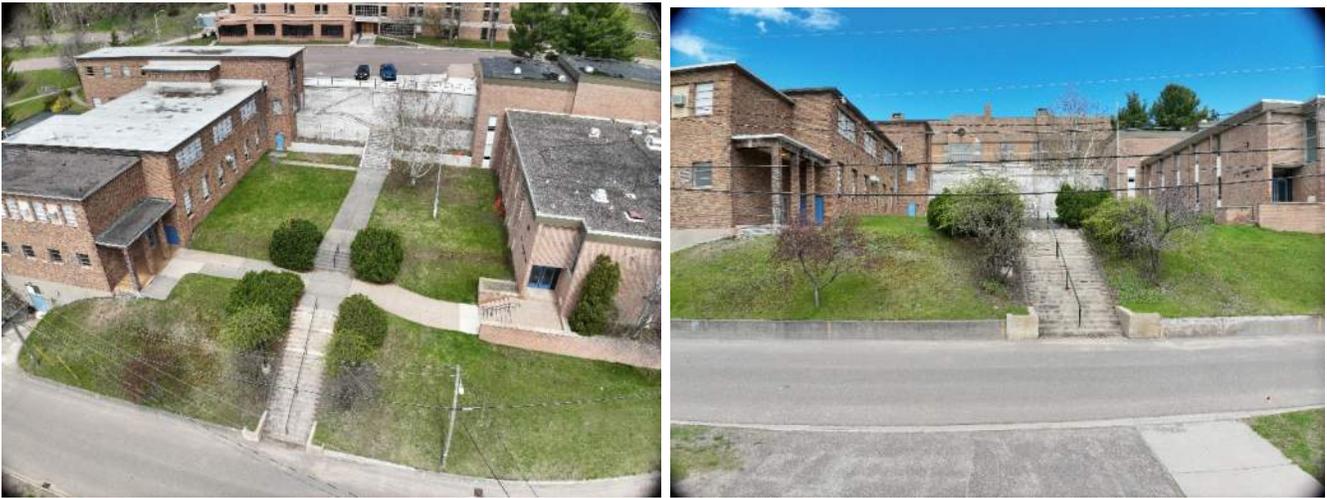
The courtyard is a 15,000 sf landscaped outdoor area wedged between Nikander Hall and Wargelin Hall. It has a concrete walk from Franklin Street up to the Summit Street parking lot. The walk provides access to the East entrances of Nikander and West entrances of Wargelin Hall. With the change in elevation between Franklin St and the parking lot, the walk has three sets of stairs with a large concrete retaining wall. The concrete stairs and retaining wall are showing signs of degradation and are beginning to crumble. The retaining wall steps are also missing a few sections of handrails, posing a safety concern that would need to be addressed prior to opening to pedestrians.

Recommendation: It is recommended to perform repairs to the retaining wall and steps to increase their longevity as well as minimize safety hazards. Handrails would also need to be installed on the retaining wall steps.
