January 2025

Franklin Street Sites - Facility Assessment

Hancock MI, 49930

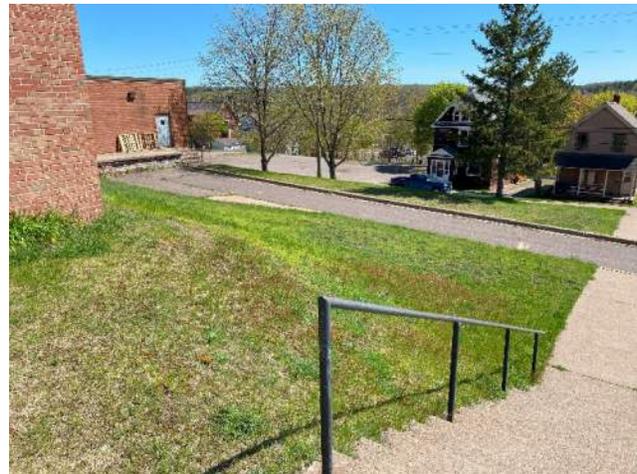
Service Drive on West Side of Building

Reconstruct the asphalt parking lots to gather stormwater runoff and perform select repairs on damaged curb-and-gutter and sidewalk.

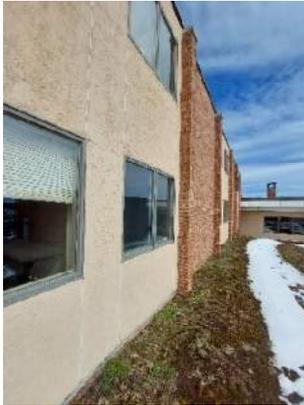
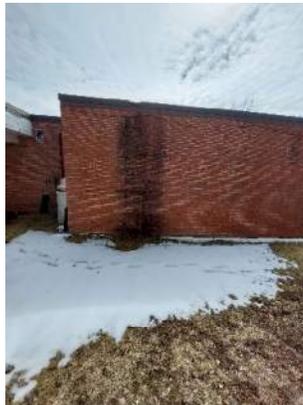
The majority of the building is faced with brick masonry and EIFS/Stucco. There are some small areas of brick which show efflorescence and some small areas in need of re-pointing. The kitchen addition is the area that has the most concern regarding the condition of the brick. It is apparent that there has been water issues and attention is needed at the scupper locations where there has been a severe degradation of the mortar joints. There is some cracking visible and some joint deterioration in the EIFS/Stucco. The EIFS/Stucco was not the original cladding of the building and the exact construction of the wall system in these areas is unknown.

Perform maintenance at building exterior, replacing existing sealants. Re-point damaged areas of brick especially at kitchen addition. Install conductors at the scuppers from the kitchen addition roof to avoid further damage to the brick surface.

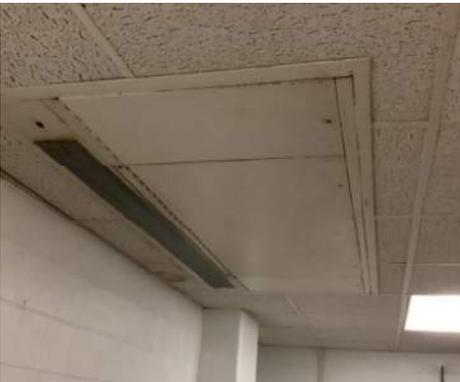
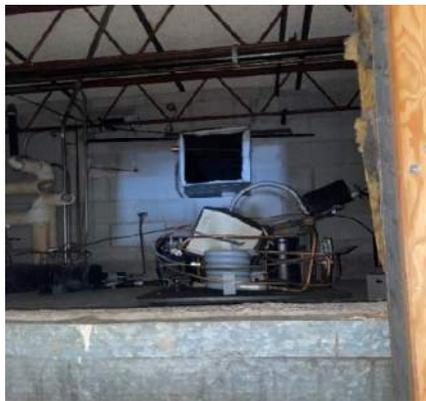
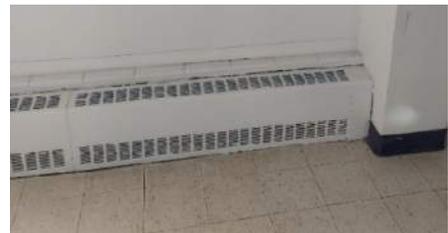
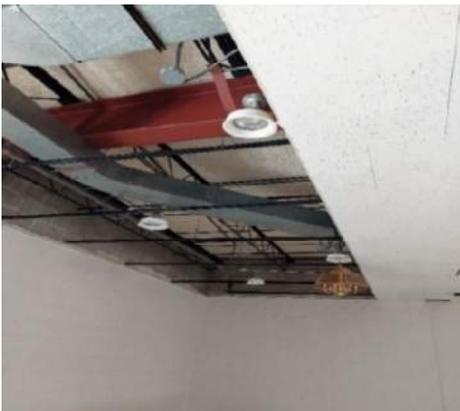
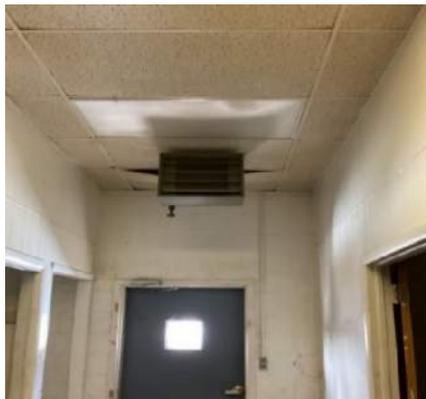
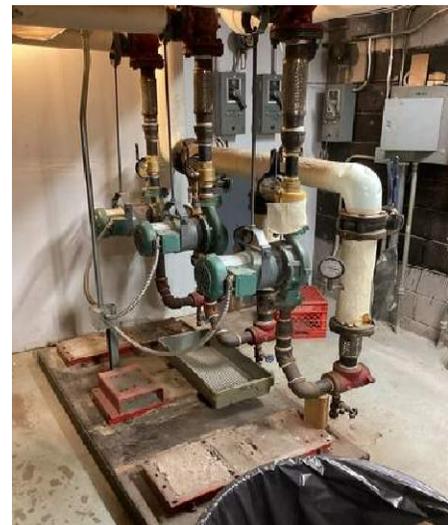
The building's heating system consists of a 2,000 MBH hot water Rite boiler that was installed in 1988. The unit is still in good operating condition but is approaching 40 years of service. The boiler also feeds the Nikander Hall addition hydronic mechanical equipment. The pumps located in the mechanical room are still in good condition. The heating distribution piping is a combination of schedule 40 black pipe and copper pipe. The offices, classrooms, kitchen, and dining hall are heated with convectors and finned tube radiation and about half of them are currently working. The convectors and finned tube are controlled in zones, so each room does not have individual control. Two-unit ventilators provide ventilation air for the kitchen and dining hall but have been taken out and ductwork has been disconnected. All ductwork and diffusers in the kitchen and dining hall have been left in place. A unit ventilator, that is not operational, on the ground floor provided ventilation air to multiple rooms. There is currently no ventilation air being provided to the building. The restrooms have exhaust ductwork connected to powered roof/ceiling exhaust fans that were not operating while onsite.

The compressor for the pneumatic control system looks to be original to the building. The air lines are in place and operational. The compressor has been running continuously during every visit. It seems there may be a leak in the system.

Replace the boiler and pumps. Replace the nonfunctioning convectors and finned tube radiation. Add ventilation to the spaces in the building as required per code. Replace exhaust fans or add energy recovery units for the restrooms. Remove pneumatic control system and replace with a digital control system.

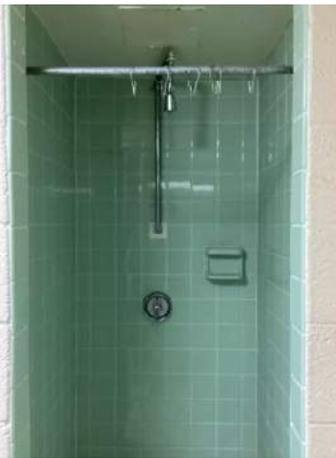
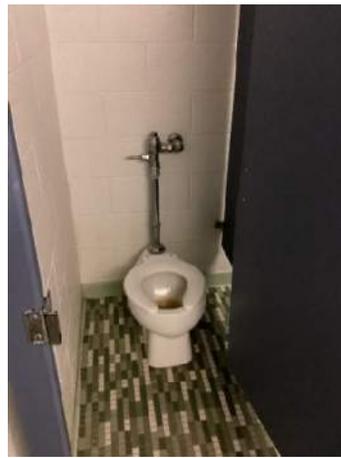
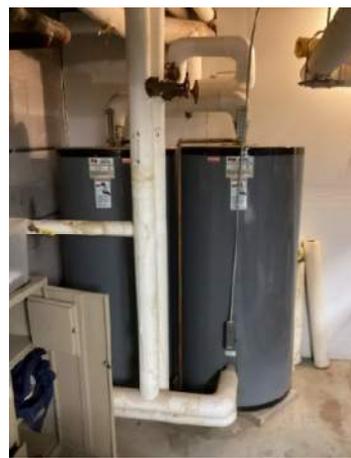
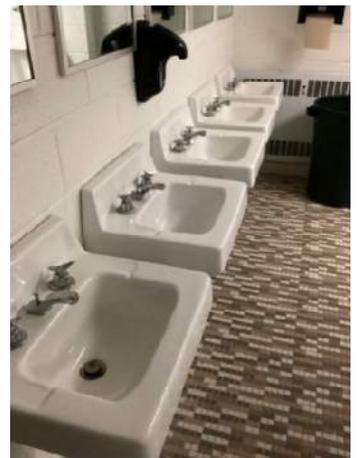
There are six gang toilet rooms, three men and three women, throughout the building that include lavatories, water closets, urinals, and showers. The ground floor has an additional men's and women's restroom. The first floor has a restroom off the kitchen that includes a lavatory, water closet, and tub/shower. All plumbing fixtures are original to the building and are in poor condition. The water closets are floor mounted with manual flush valves and the lavatories are a combination of manual and sensor faucets. There are two laundry rooms, each with washer hookups and a sink. There are five janitor closets, each have a mop sink.

Replace all fixtures. Replace roof drains when roof is replaced and add overflow drains. Review the condition of the domestic water and sanitary piping. Replace the hot water storage tanks with storage water heaters. Add fire suppression piping and sprinkler heads to the building.

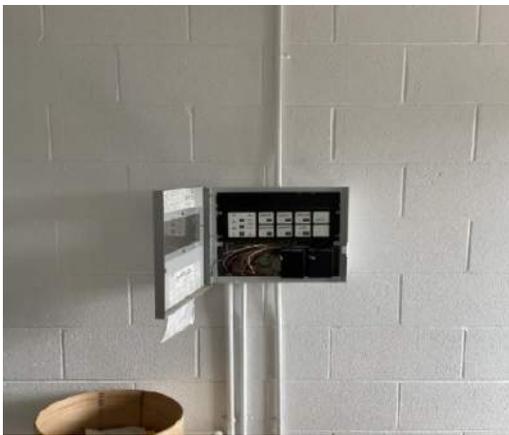
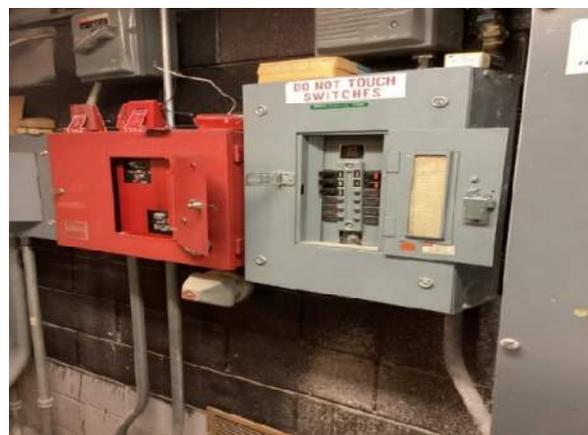
Each dormitory room and the corridors contain standalone battery-operated smoke detectors. None of the devices tested during our walk through were in working order.

Recommendation: The fire alarm system is past its useful life. Install a new addressable fire alarm and detection panel, replace input and notification devices, and add devices where needed to bring the system up to current codes.

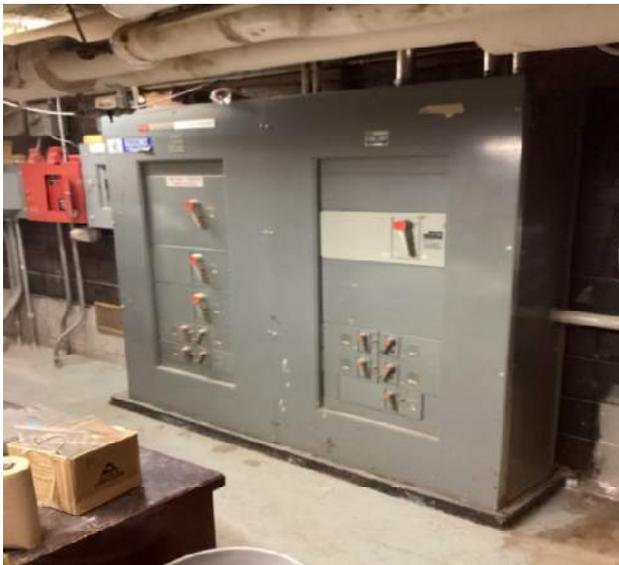
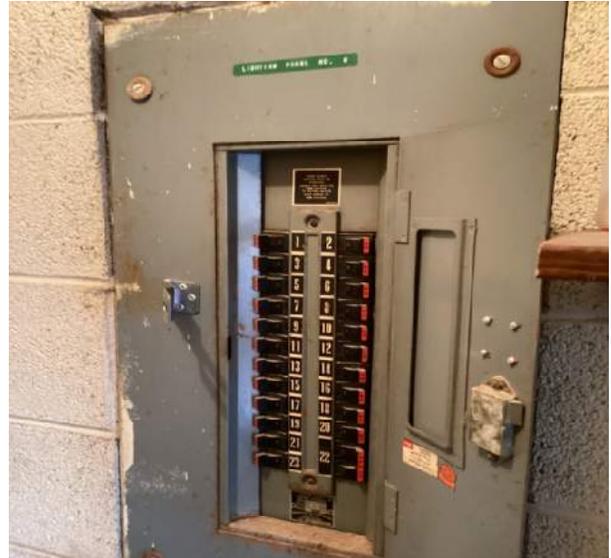
Multiple 100A and 200A main lug only federal pacific branch panels are placed throughout the building to feed receptacle and lighting branch circuits. These panels are original to the building.

Recommendation: The 600A main service panelboard is close to 60 years old and past its service life. This panelboard should be replaced as replacement parts will not be readily available. The Federal Pacific branch panels are also 60 years old and past service life. This brand is known to cause fires due to the breakers not tripping during overload conditions. Replace all panelboards in original locations with new.

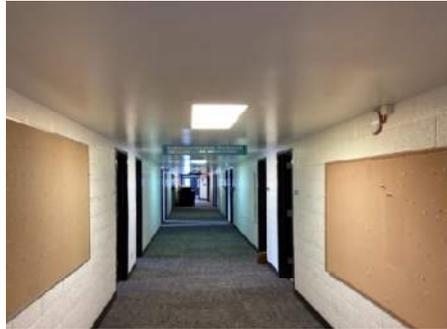
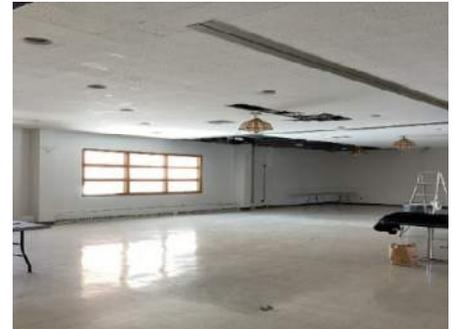
The interior lighting consists of a mix of fluorescent and incandescent light fixtures. The dormitory room lighting consists of E17 base fluorescent light bulbs in original light fixtures. The hallways consist of tube type fluorescent bulbs in recessed mount 12”x48” fixtures. The cafeteria area contains incandescent recessed can lights throughout.

Recommendation: Replace interior lighting in dormitory rooms with LED bulbs and new integral LED light fixtures in the hallways and cafeteria space.

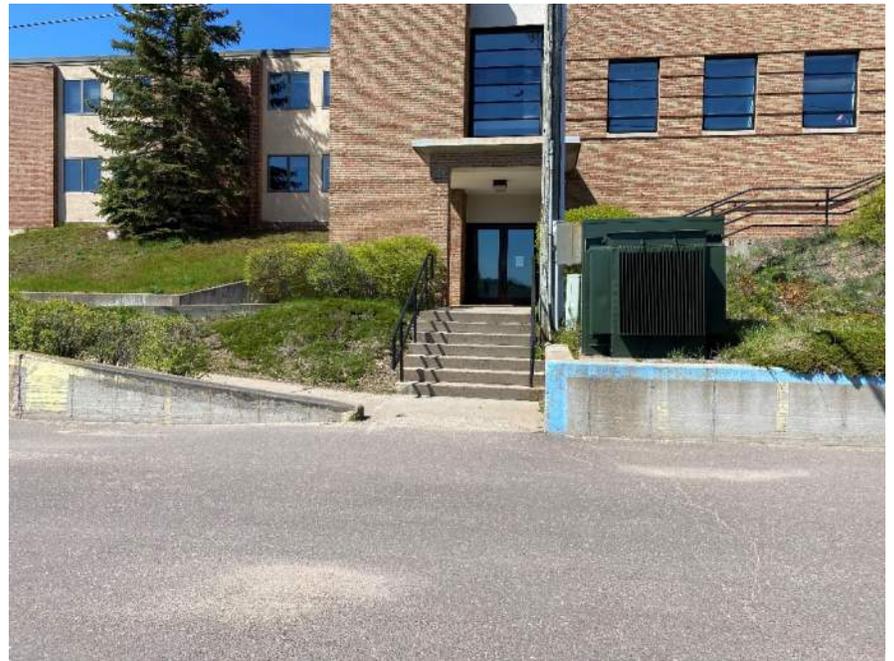
SW Building Entrance (Franklin Street)

Provide ADA entrances to levels of the building that will be intended to serve as a public entrance. The most feasible entrances for ADA access from a parking spot to the building would be from the north parking lot to the northeast entrance and on-street Franklin parking to the southwest basement entrance. Perform miscellaneous curb-and-gutter and sidewalk repairs.

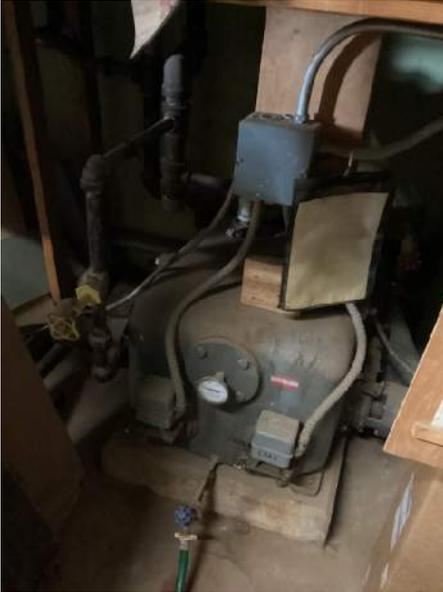
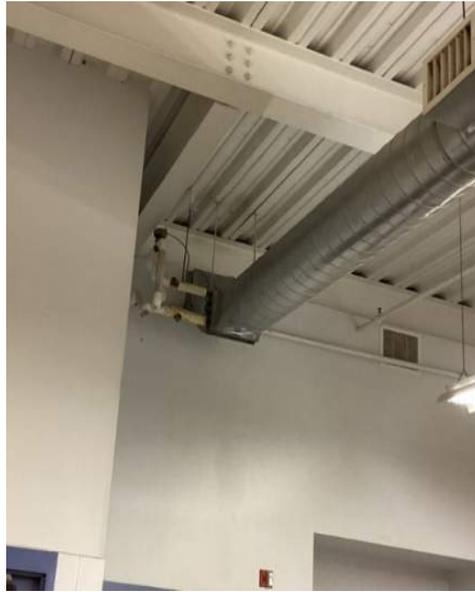
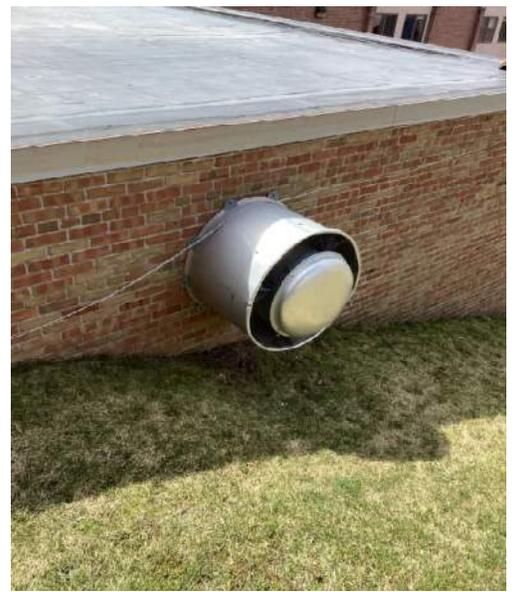
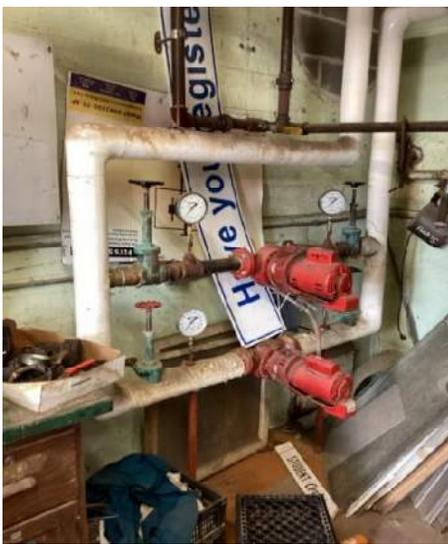
The majority of the first floor has an air handling unit (AHU) with duct heating coils that are fed from the hot water boilers in Mannerheim Hall. The pumps are located in the mechanical room in Nikander Hall and some of the hydronic piping requires patching or replacement. The AHU includes heating, cooling, and ventilation and the unit was not in operation during the walkthrough. The cabinet unit heaters and unit ventilators located throughout the building are served by a steam boiler located in the Wargelin Hall boiler room. There is some ductwork and grilles/diffusers on the second and third floor, but it is unknown where the unit is located or if it is operational. Some rooms have wall mounted A/C units. There are grilles in each of the toilet rooms ducted to exhaust fans.

Verify the age of the AHU's and if they are operational. Verify they are sized appropriately for the spaces and there is adequate ventilation. Add new units and replace existing units as needed to meet ventilation requirements. Remove the steam piping throughout the building and cap the pipes where they come from Wargelin Hall. Remove and replace all convectors. Add boilers and pumps to the mechanical room in Nikander Hall and route new hydronic piping to heating coils and convectors.

Remove all pneumatic controls and air lines and replace with a digital control system.

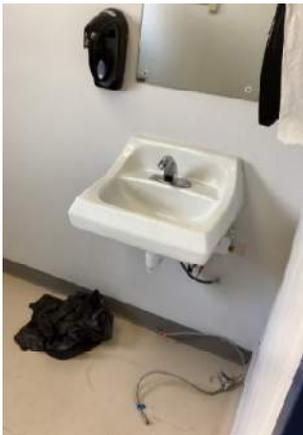
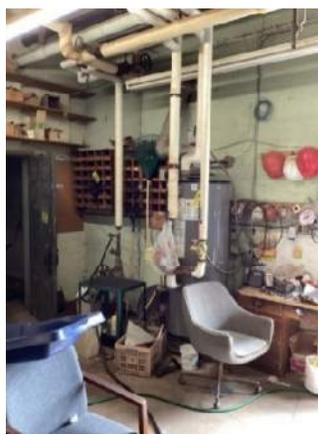
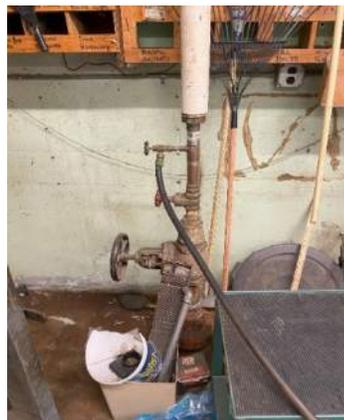
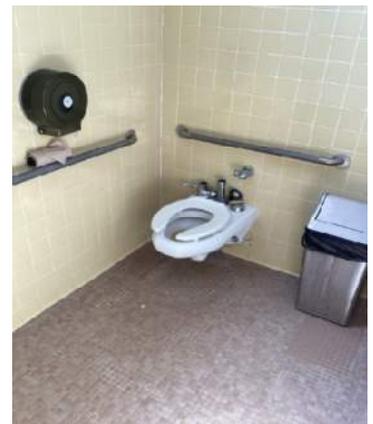
fixtures appear to be in good condition, but the flush valves have been dismantled to avoid freezing during winter. There are no janitor closets.

Fixtures can be salvaged as they are all in good condition. Replace roof drains when roof is replaced and add overflow drains. Review the condition of the domestic water and sanitary piping. Verify the water heater is sized adequately and replace if needed. Add fire suppression piping and sprinkler heads to the building. A separate water main would need to be added with a meter.

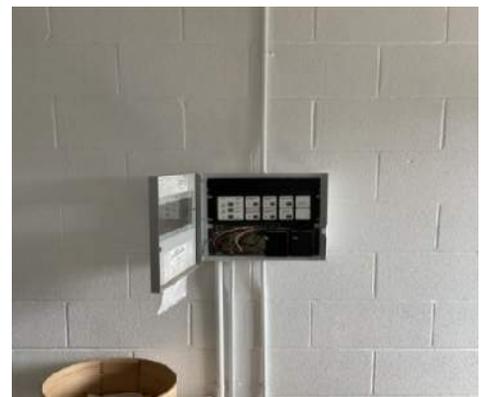
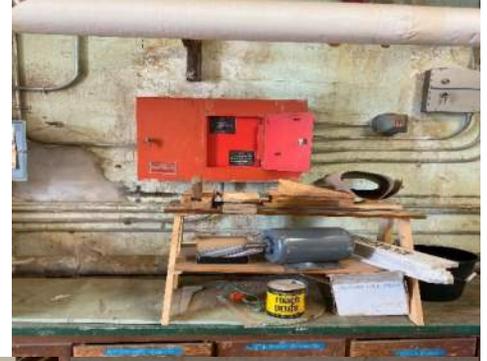
The building contains a fire alarm and detection system. The system consists of pull stations, horns, strobes, bells, flow switch, tamper switch and smoke detectors. Device mounting heights and locations do not meet building codes and regulations. The fire alarm system is past its useful life.

The main fire alarm control panels (FACP) are located in the electrical/mechanical room and in an office in Mannerheim hall located on the first floor in the east area. The original building fire alarm system control panel is located in the basement mechanical/electrical room. The FACP located in the office in the east area on Mannerheim hall is a zoned EST panel. Neither panel was operational at the time of the walk through.

The classrooms in the original building contain standalone battery-operated smoke detectors. None of the devices tested during our walk through were in working order.

Recommendation: The fire alarm system is past its useful life. Install a new addressable fire alarm and detection panel, replace input and notification devices, and add devices where needed to bring the system up to current codes.

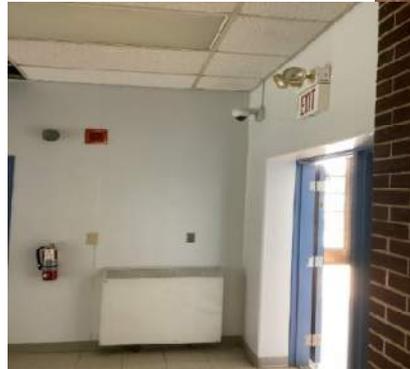
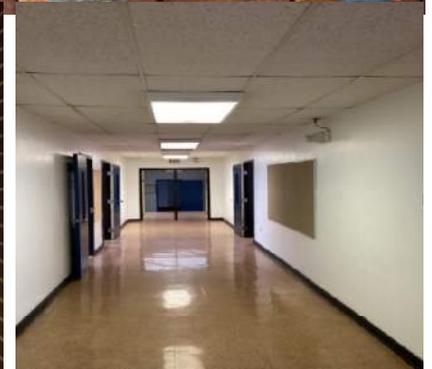
The facility does not have a standby generator. Building egress lighting uses incandescent polycarbonate combination emergency exit signs and emergency battery units. Egress lighting does not meet current code in the interior and at the exterior of the building.

Recommendation: Replace the interior incandescent emergency lighting fixtures with LED fixtures with battery backup. Add fixtures as needed to bring the emergency egress lighting up to current requirements.

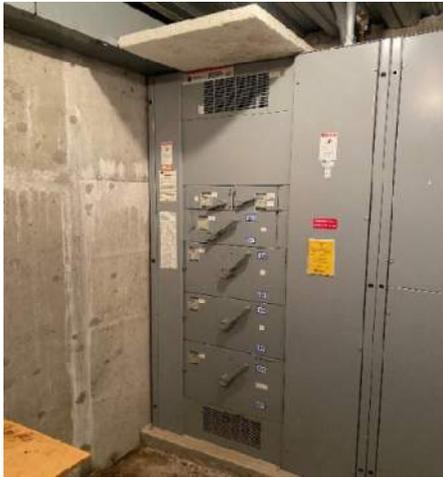
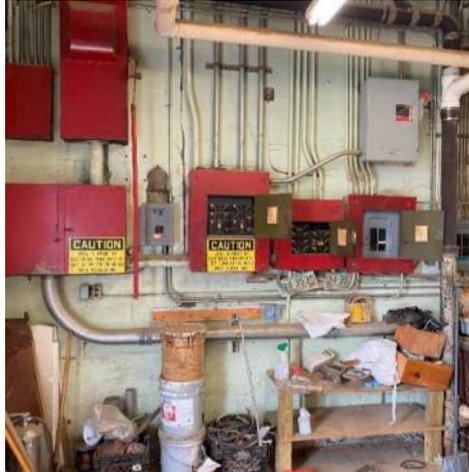
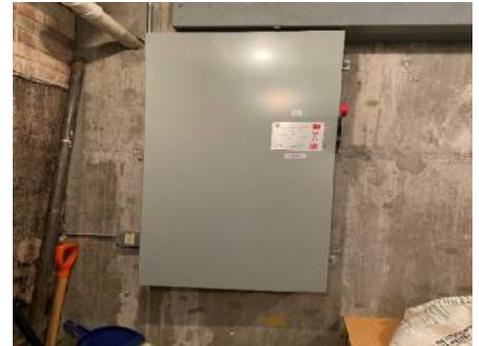
Multiple 400A main lug only Cutler Hammer panels are placed throughout the Nikander addition to feed receptacles, shop equipment and lighting branch circuits. These panels are original to the addition. The original Nikander building has multiple original branch panels and updated 100A square d panelboards on each floor.

Recommendation: The 1600A main service panelboard is in good condition. A single main service disconnect should be added in front of the main service panelboard for added future loads. The original distribution panelboards in the basement mechanical/electrical room will need to be replaced. To separate Mannerheim and Nikander an additional metered service will need to be installed as these buildings are currently on one electrical meter.

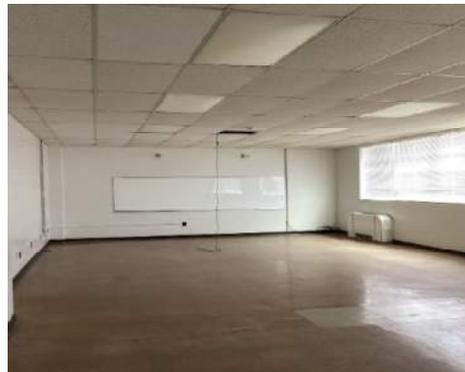
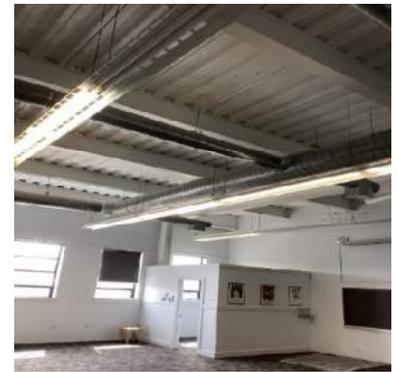
The interior lighting consists of a mix of fluorescent and incandescent light fixtures. The classrooms and corridors consist of tube type fluorescent bulbs in recessed and surface mount 24"x48" fixtures. The lab and shop areas contain 8' fluorescent pendant hung strip light fixtures. The stage area and closets consist of incandescent type fixtures.

Recommendation: Replace interior lighting new integral LED light fixtures in all spaces.

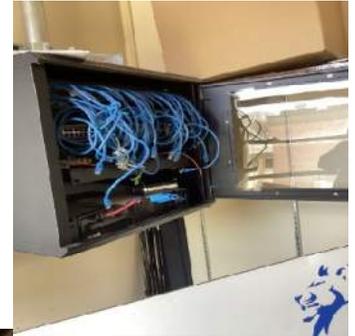
The building has two IT racks with switches, patch panels and an uninterruptible power source UPS. These racks feed data jacks located in most of the individual classrooms and wireless access points (WAPS) spread throughout the building. Each rack includes conduits where most of the cables are routed to the IT rack. The switches in the racks are fed by a fiber optic cable. Fiber optic feed originates from Wargelin Hall. A new communication service will need to be installed if the properties are split. Existing IT infrastructure will be useable for a new system.

Recommendation: No current recommendations.

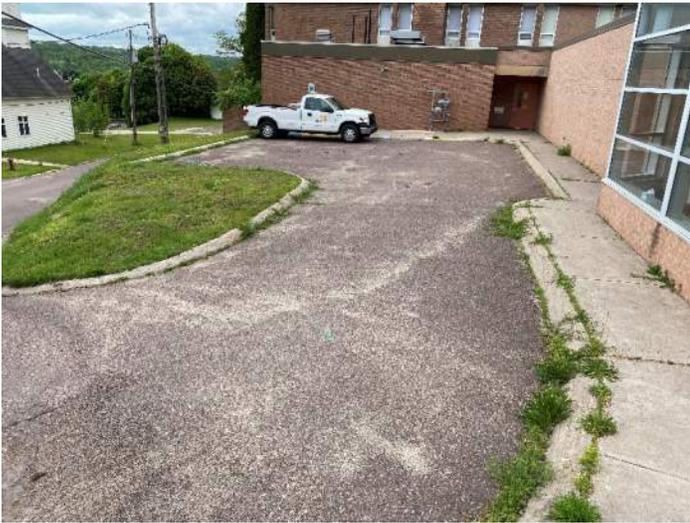
SE Parking Lot and Entrance (Franklin Street)

There is a small parking area providing access to the southeast building entrance. This area is currently striped for 3 parking spaces. One of the spaces is striped and signed as an ADA space but does not meet the current ADA standards for sidewalk ramp and landing layout. The depth of this lot is 2 feet shorter than the recommended minimum for 90-degree backout parking. The entrance width is also narrower than the recommended minimum for 2-way traffic.

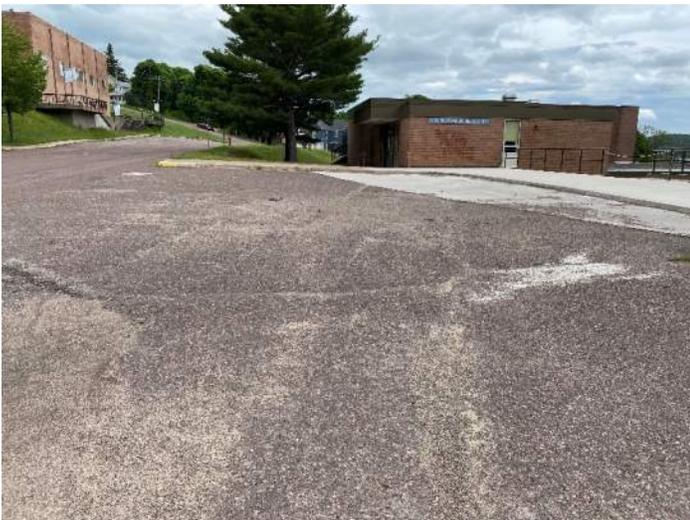
Shared Parking Lot with Nikander Building

An approximate 21 car parking lot is located on the north side of the site, accessed from Summit Street. This lot provides access to both Wargelin and Nikander buildings. This lot is surrounded by a ~12-foot-wide sidewalk. The cross-slope of the sidewalk is greater than 2.0 percent and the ramp into the parking lot is greater than 8.33 percent, not meeting ADA guidelines. The surface of this parking lot is a mix of concrete and asphalt. This is the same parking lot addressed in the Nikander assessment. The asphalt surfaces in the parking lots are deteriorating and the grades show signs of settlement.

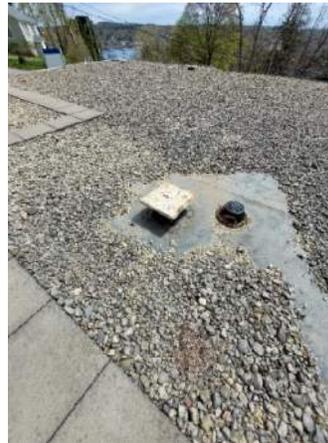
The majority of the roof surface is a loose laid EPDM membrane with rock ballast. The membrane shows some possible shrinking at the roof edges. Seams are not visible due to the ballast. Water marks inside the building indicate that there may be leaking in areas. Insulation of the roof system over the addition (1996) is 4” of rigid insulation which was standard for that time but may not meet current Code requirements. Insulation of the roof system over the original building was originally indicated to be 1” rigid insulation. It is unknown if additional insulation was added later, but it is expected that current insulation is less than current standards and code requirements. Roof drains are present and appear to be functional. Roof drain capacity was not verified.

A section of roof above the boiler room is an asphalt built-up roof. This area is in poor condition and leaking is evident at the interior.

Replacement of the entire roof system is recommended. A fully adhered membrane system is recommended (remove all existing ballast). Additional insulation could be added during roof replacement.

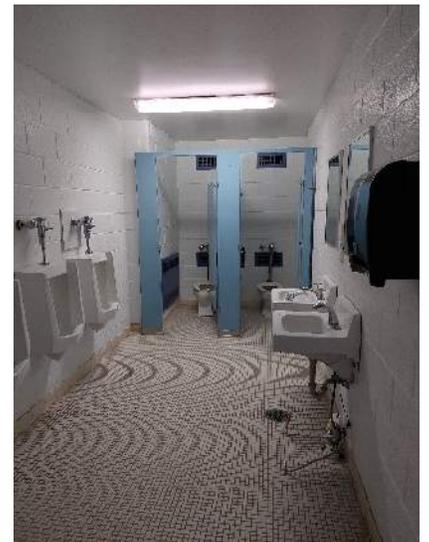
The building contains four levels with stair access to all levels. There is no elevator in the building. Grade access is available at the first floor and the third floor. These accesses appear to largely comply with accessibility requirements and only minor modifications may be needed to provide accessible entries at the first and third floor. There is only stair access to the second floor, there is no path for a wheelchair to access this floor. There is also only stair access to the boiler room level.

Toilet rooms on the first floor appear to comply with most accessibility requirements, minor modifications may be required to bring them up to current requirements. Toilet rooms on the second and third floor do not comply with requirements.

Most of the building’s doors appear to meet the current requirements for accessibility clearances. The majority of the hardware on the second and third floors appears to be knobs which do not meet current accessibility requirements.

Modify first floor toilet rooms to comply with current accessibility standards. Renovate spaces on the second and third floor to accommodate accessible toilet rooms as part of any future renovation. Install ramps and/or modify exterior grade as required to provide accessible entries at all grade access doors. Proposed use of the building may make an elevator desirable to reach levels required to be accessible during future renovation. Replace door hardware as necessary. Consider adding exterior grade level entrance to boiler room.

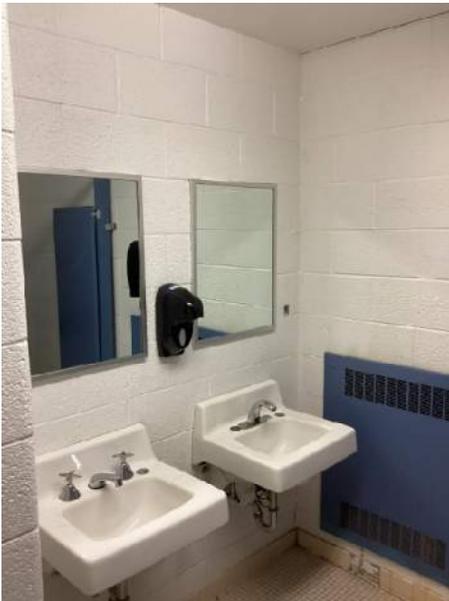
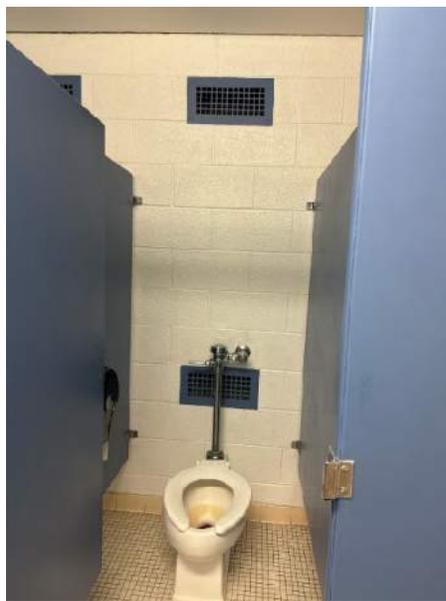
There are six gang toilet rooms, three men and three women, throughout the building. These toilet rooms include water closets, lavatories, and urinals. The floor mounted water closets and wall mounted urinals have manual flush valves, and the lavatories are a mixture of sensor and manual faucets. Some of the water closets look to have been replaced but most are old. The urinals, lavatories and faucets all look to be in good condition. There are three janitor closets, one on each floor, each with a mop sink and faucet.

Replace all fixtures. Replace roof drains when roof is replaced and add overflow drains. Review the condition of the domestic water and sanitary piping. Replace the electric water heater with a gas water heater. Add fire suppression piping and sprinkler heads to the building.

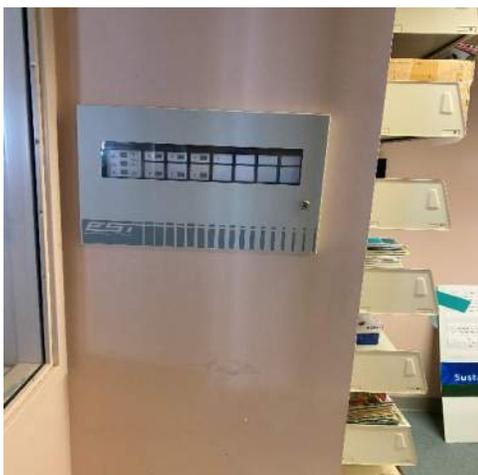
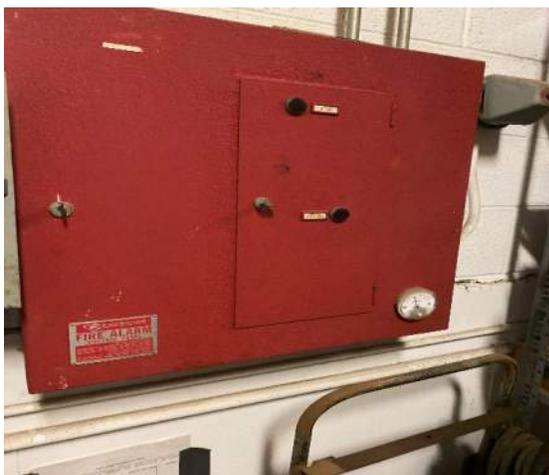
The classrooms and office spaces in the original building contain standalone battery-operated smoke detectors. None of the devices tested during our walk through were in working order.

Recommendation: Install a new addressable fire alarm and detection panel, replace input and notification devices, and add devices where needed to bring the system up to current codes.

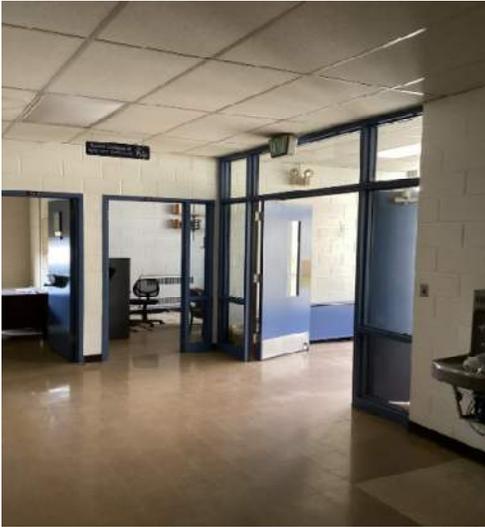
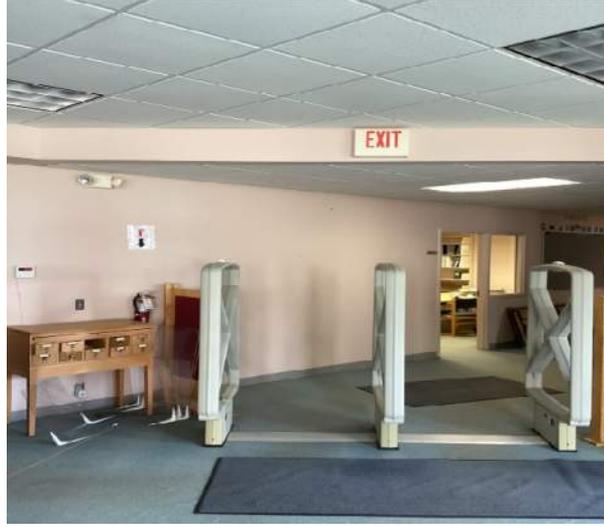
The facility does not have a standby generator. Building egress lighting uses incandescent polycarbonate combination emergency exit signs and emergency battery units. Egress lighting does not meet current code in the interior and at the exterior of the building.

Recommendation: Replace the interior incandescent emergency lighting fixtures with LED fixtures with battery backup. Add fixtures as needed to bring the emergency egress lighting up to current requirements.

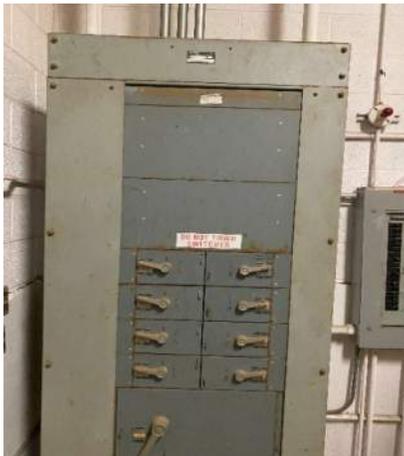
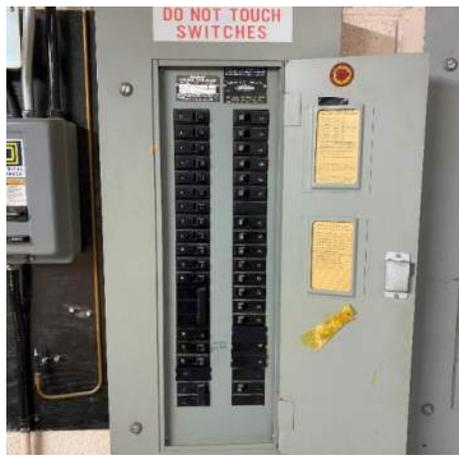
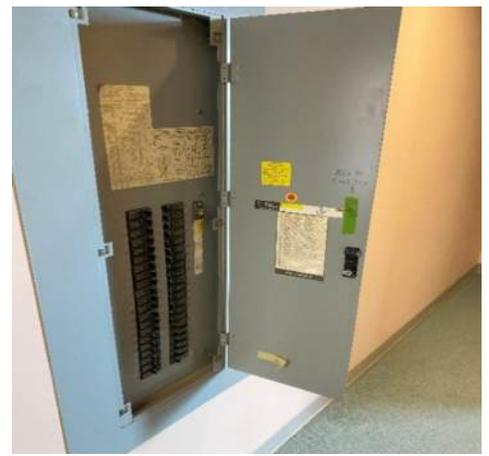
Electrical service consists of a 400A panel board containing a 400A, 208V/120V three phase fusible main service disconnect switch. The panelboard contains one section feeding multiple panels throughout the building. The panels are fed by 100A and 60A fused disconnects. The main gear is Westinghouse brand and original to the building.

Multiple 225A and 100A main lug only Westinghouse branch panels are placed throughout the building to feed receptacle and lighting branch circuits. These panels are original to the building. Multiple 225A and 125A GE panels were added in the late 1990's to feed an addition to the library.

Recommendation: The 400A main service panelboard is close to 60 years old and past its service life. This panelboard should be replaced as replacement parts will not be readily available. The Westinghouse branch panels are also 60 years old and past service life. Replace these panelboards in original locations with new. The GE panelboards are in good condition and can remain.

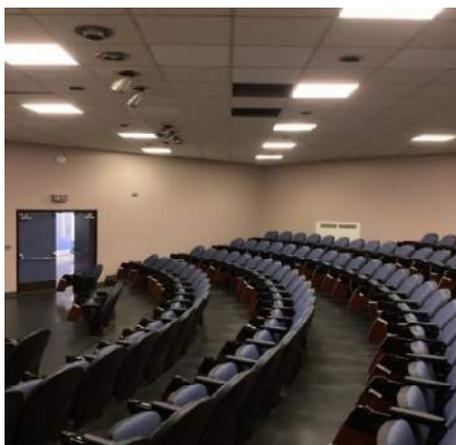
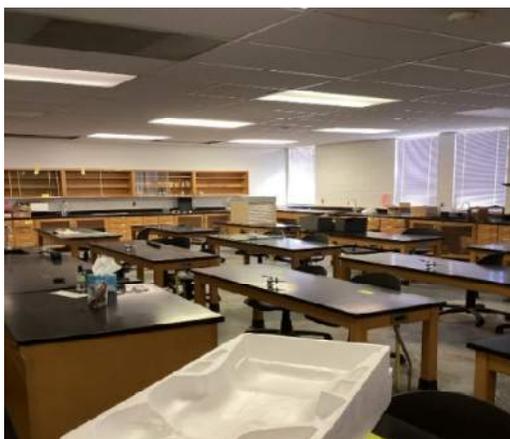
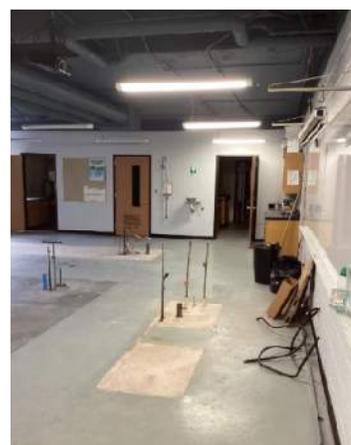
The interior lighting consists of a mix of LED, fluorescent and incandescent light fixtures. The chemistry lab contains newer led pendant light fixtures. All other classrooms, the library, offices and corridors consist of tube type fluorescent bulbs in recessed 24"x48" fixtures. The lecture hall contains 2'x2' fluorescent fixtures, incandescent recessed can lights and incandescent spotlights.

Recommendation: Replace interior lighting new integral LED light fixtures in all spaces.

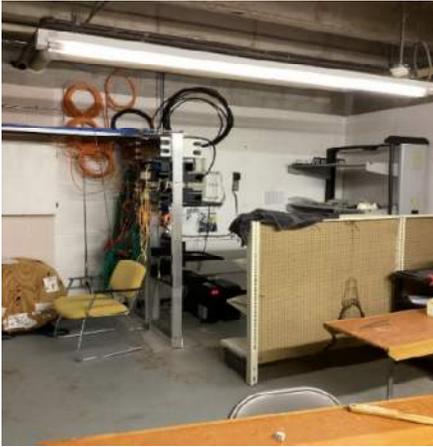
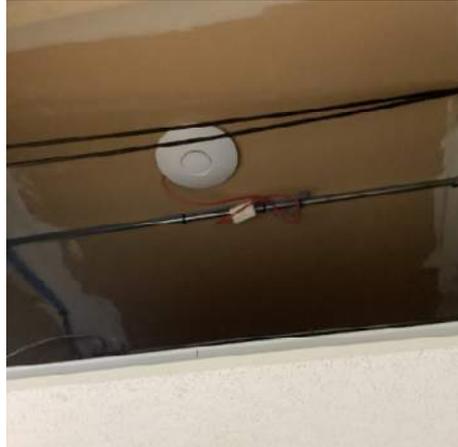
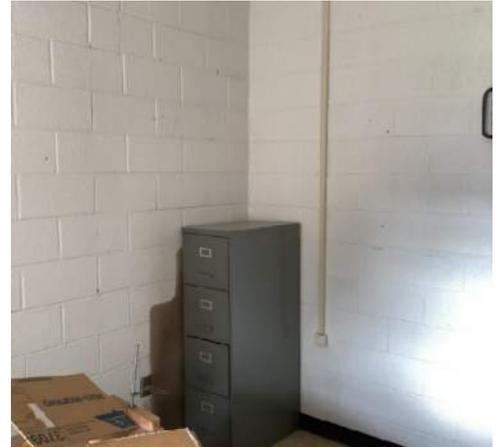
The building has an IT rack with switches, patch panels and an uninterrupted power source UPS. The rack feed data jacks located in most of the individual classrooms and wireless access points (WAPS) spread throughout the building. The rack includes cable tray for the cables routed to the IT rack. The switches in the racks are fed by a fiber optic cable. This rack contains the main feed from the utility and a fiber patch panel to feed the other buildings on campus. Existing IT infrastructure will be useable for a new system.

Recommendation: No curenent recommandations.

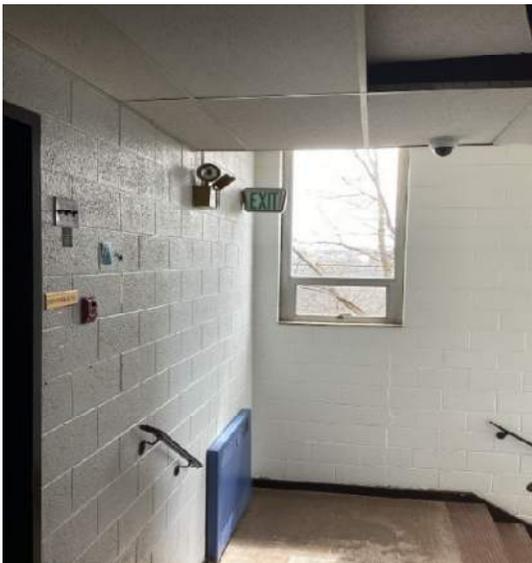
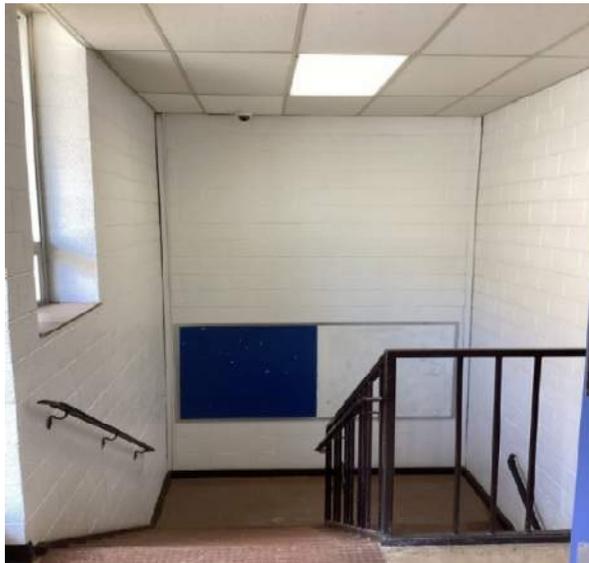
VIDEO SURVEILLANCE SYSTEM

Currently there are multiple cameras in corridors and on the interior side of most exit doors.
